Northern Engineering

Beaver Island Boat

Vibration Analysis Report – 9/27/2021

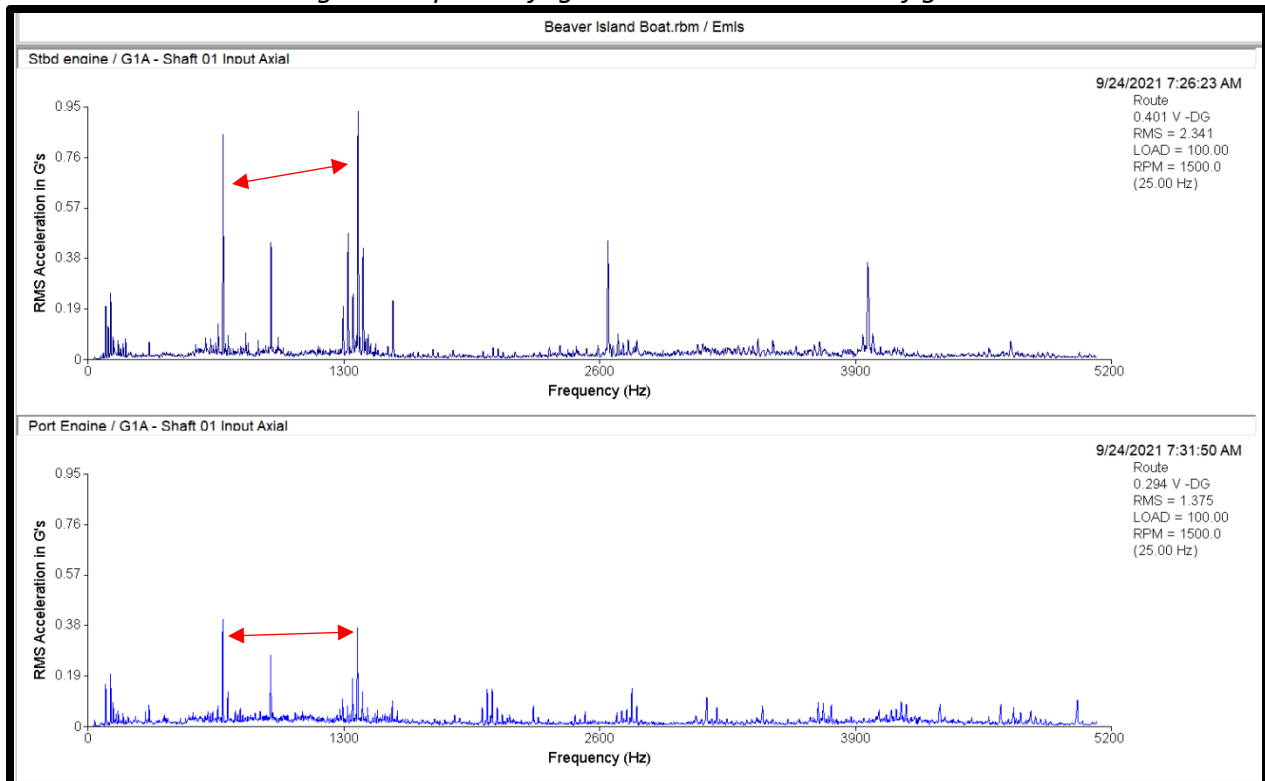
The axial reading is higher on the STBD engine and marine gear.

*This is both engine axial reading and you see it is higher on STBD side. (Stbd .95 Gs) (Port .42 Gs)
The red lines are marking the output shaft gear mesh and harmonic of gear mesh.*

The axial reading on the Starboard machine train could possibly relate to angular misalignment and /or a bent shaft. The extra thrust on this side will also have more wear on gears and bearings in the marine drive.

Investigate the Starboard shaft and coupling on why this is not coming apart, and/or which might include pulling shaft.

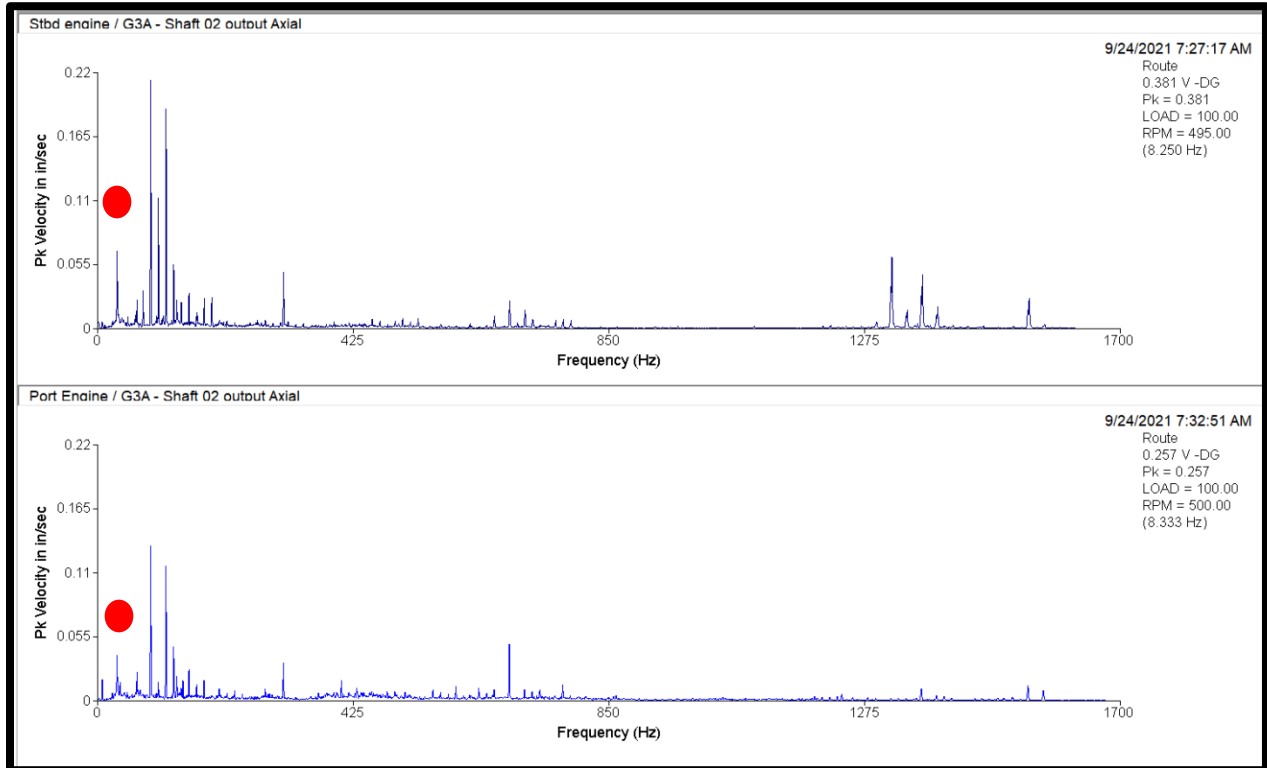
These are the axial readings of both gears and the highest is on the STBD side. Blade pass is the red mark.

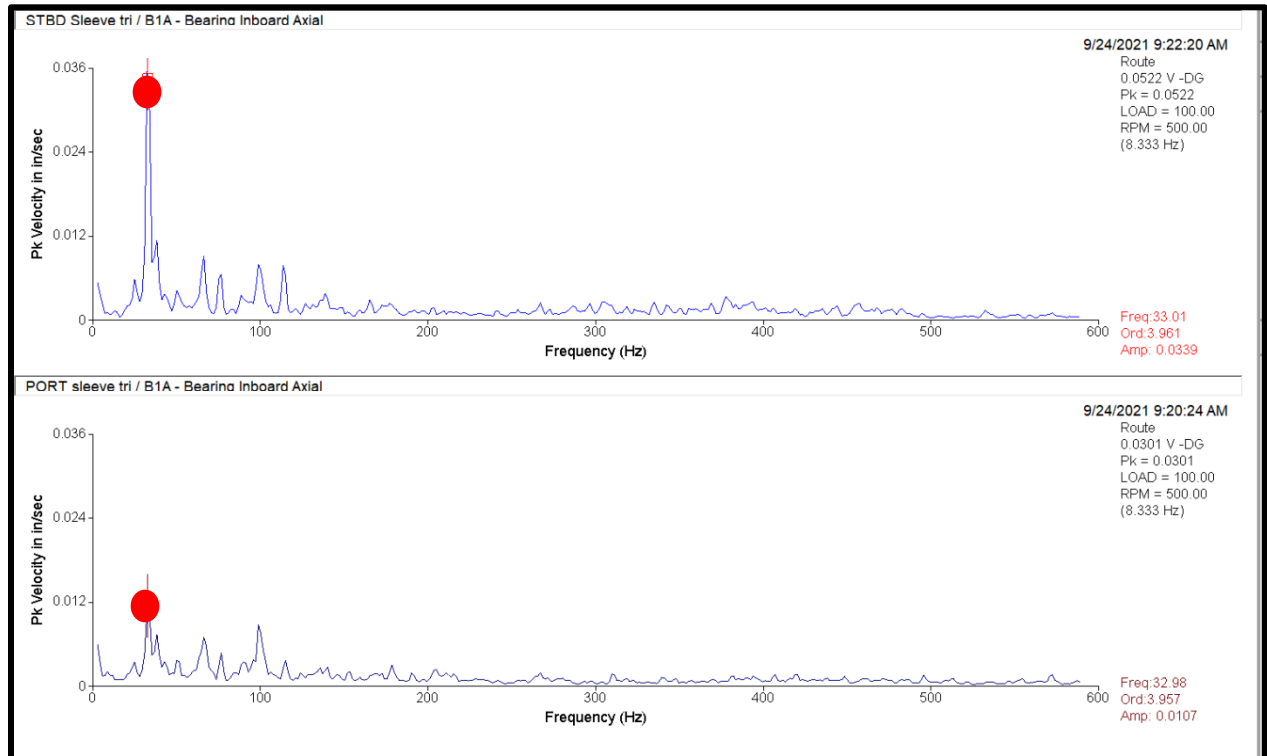
These are the readings taken in the FWD lazarette over sleeve bearing. Blade pass is red mark.
